**DANISH MARITIME AUTHORITY**

**MARINE ACCIDENT REPORT  
DIVISION FOR INVESTIGATION OF MARITIME ACCIDENTS** ———

**DANICA SUNBEAM  
Accident to seafarers on 18 November 2009**

**The casualty report has been issued on:** 20 April 2010.

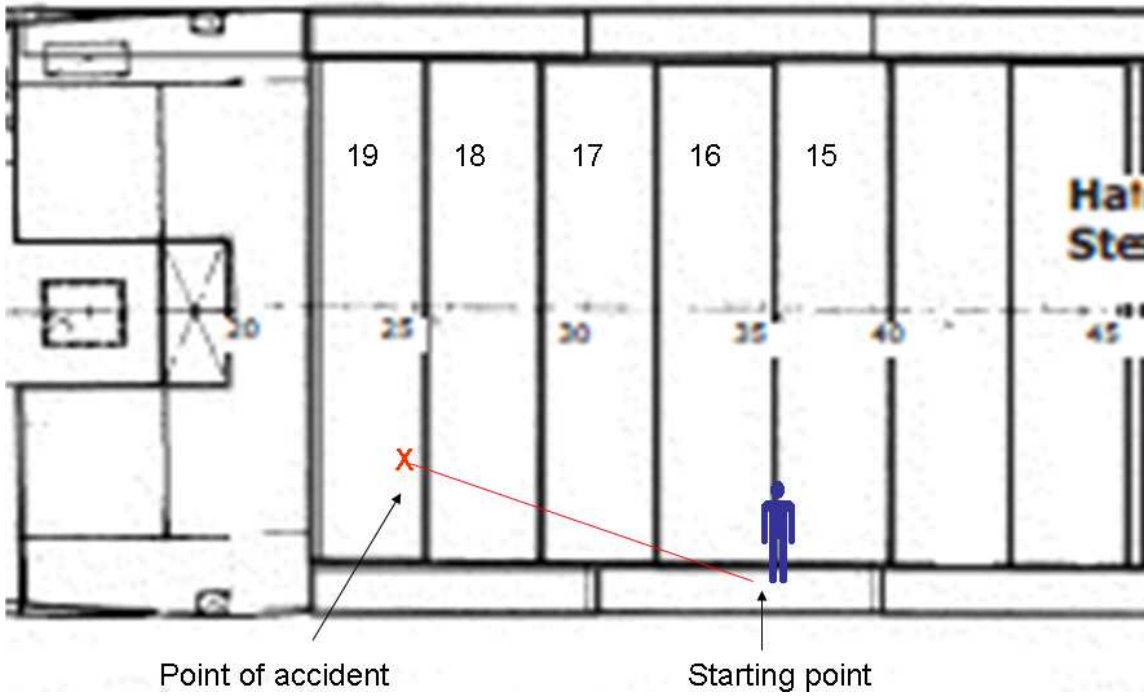
Detail from the general arrangement, tween-deck aft

Aftermost the manhole in the web frame is blocked and on the tween-deck aft a longitudinal and a transverse beam makes the passing from the passage way to the platform more difficult and even risky when pontoon number 19 is removed.

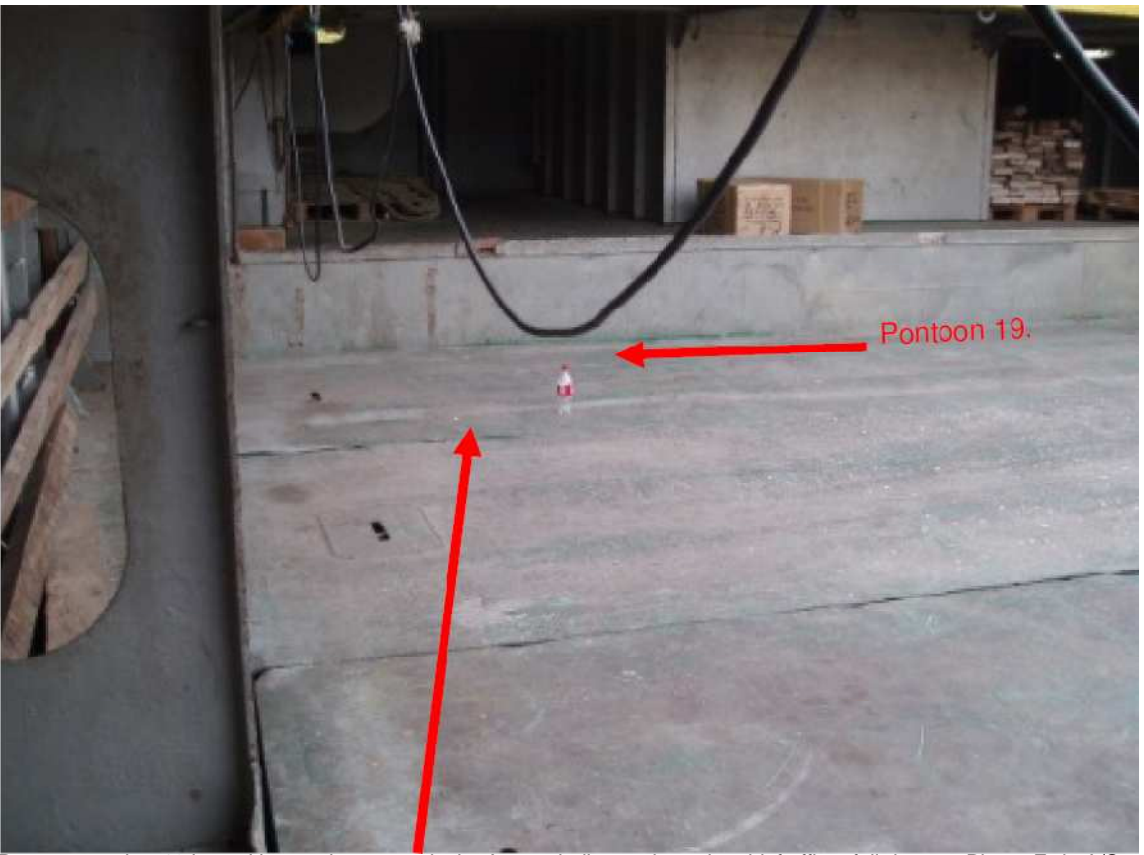
Pontoon number 19 in position on the tween-deck. Arrows indicate where the chief officer fell down. Photo: Erria A/S

The Investigation Division notes that the accident occurred because the chief officer moved from his position in starboard side of the tween-deck at pontoon number 16 towards the place where the pontoon, still hanging in the cranes, had just been removed from the tween-deck making a gap to the lower hold.

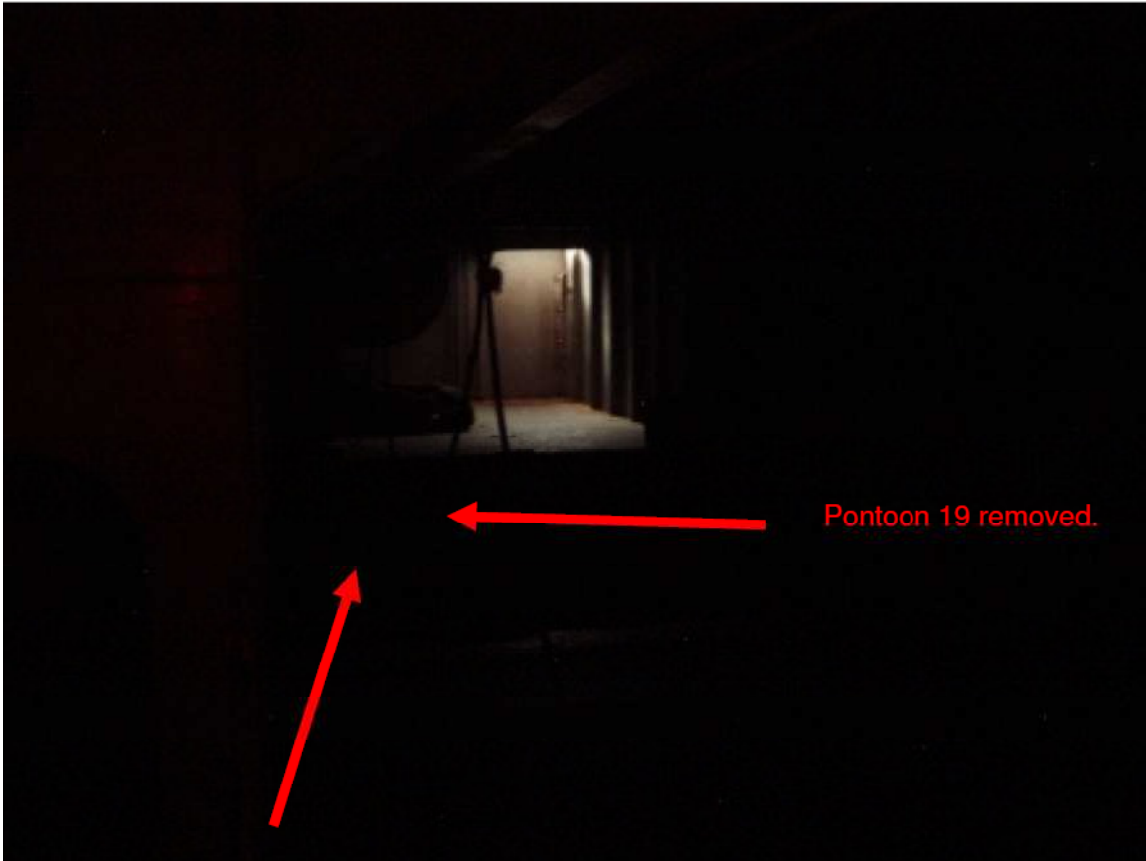
As soon as the lights in the cargo hold went out due to the black out, the chief officer left his position at the starboard side of the tween-deck aft and headed straight for the day light from the access hatch at the aft end of the hold.

However, the chief officer continued towards the light and consequently fell through the gap 2.4 metres down onto the tank top.

Pontoon number 19 in position, lights turned off. Arrows indicate where the chief officer fell down. Photo: Erria A/S

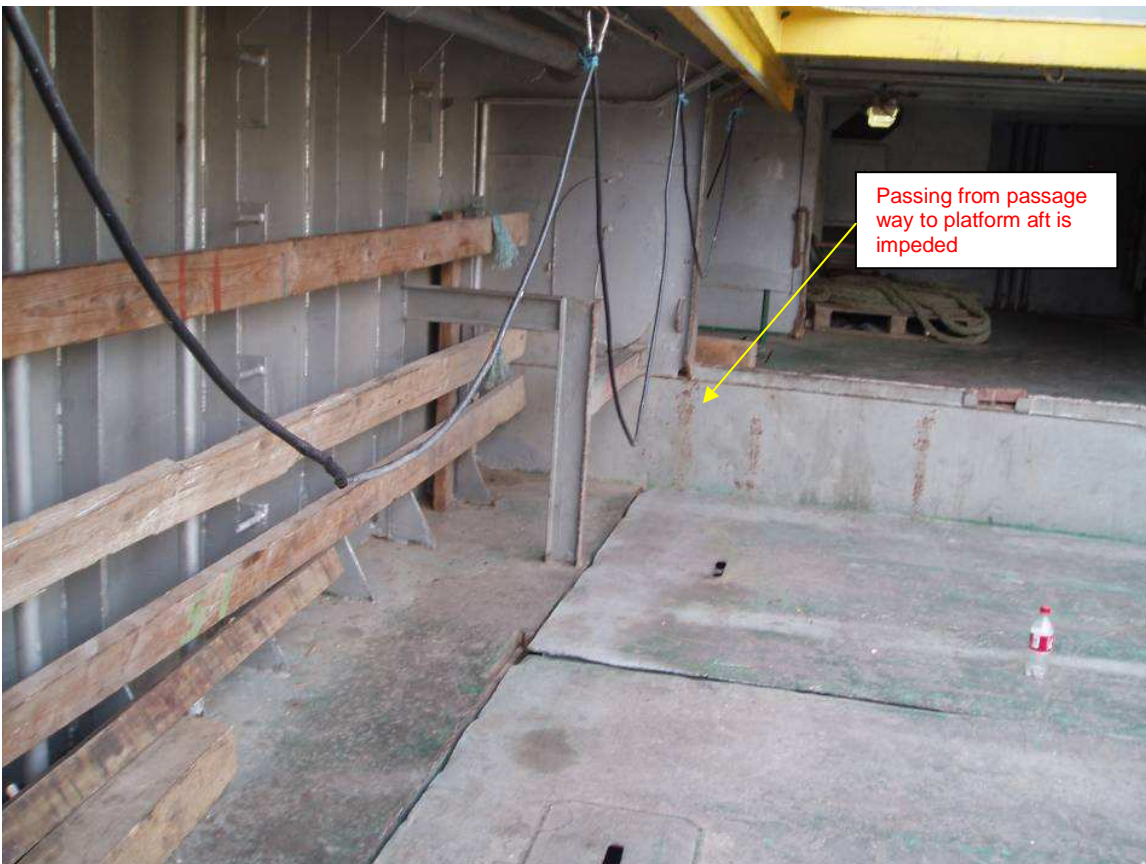
Tween-deck and passage way, starboard side.

On the tween-deck there are passage ways of 0.8 metre in breadth at each side. Passing on the passage ways is impeded by web frames with manholes (photos on pages 11 and 13).

However, using the passage way was more time consuming and aftermost the passage way was practically impossible to use without risk when the pontoon number 19 was removed.

The Investigation Division considers the surroundings on the tween-deck unsafe because the passage way along the ship's side, especially aft from the passage way to the platform, was difficult to use.

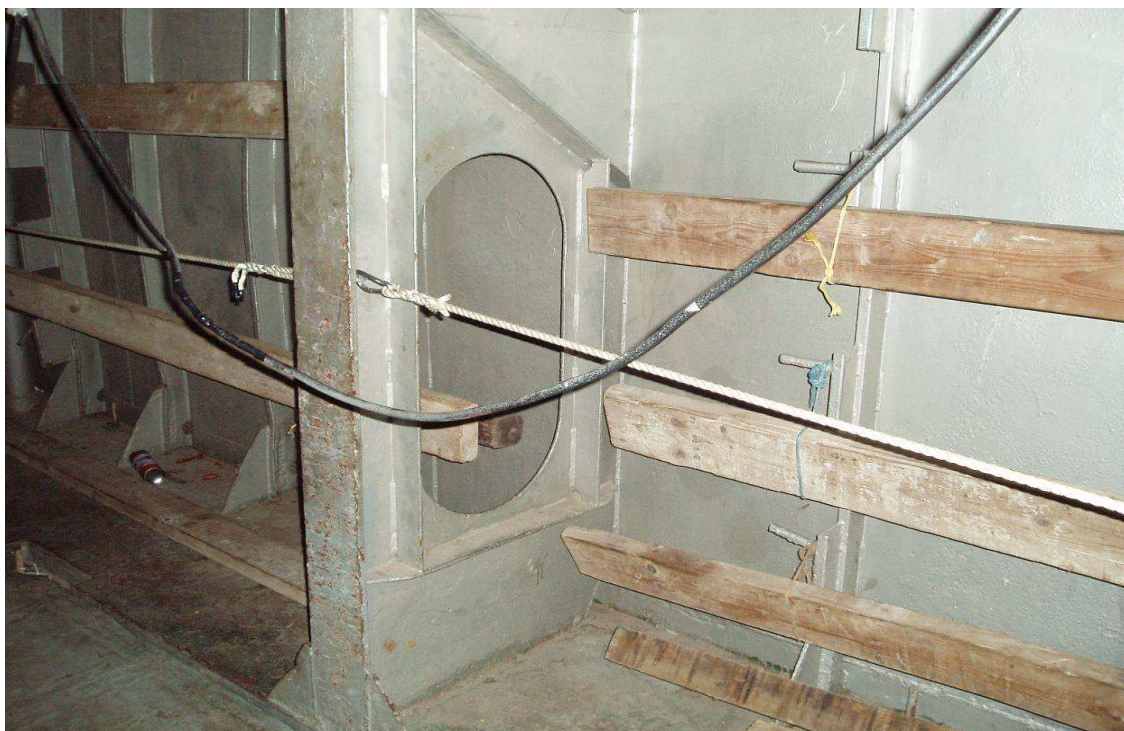
Passage way and web frame after mounting new ridge ropes with snap hooks

No ridge ropes were used on the tween-deck prior to the accident.

- *No movements of tween-deck pontoons to be made whenever the ship is moving by own power or being towed.*
- *Safety ropes (fixed in one end and a fireman's hook in the other) must for the future be used between individual web frames and gradually installed (hooked up) as tween-deck pontoons are moved away.*
- *Crewmembers always to bear a torch that can be used in emergency, when working in cargo hold with artificial lightning.*
- *Safety ropes only to be removed again when pontoons have been re-positioned.*
- *This report will be distributed to all ships in the fleet. Following requirements have been made to the ships performing this operation – updating of WPI (Work Place Instruction) for work with pontoons.*
