DANISH MARITIME AUTHORITY

**MARINE ACCIDENT REPORT
DIVISION FOR INVESTIGATION OF MARITIME ACCIDENTS**

**THOR GITTA
Fatality and injury
21 May 2009**

The casualty report has been issued on 23 November 2009.

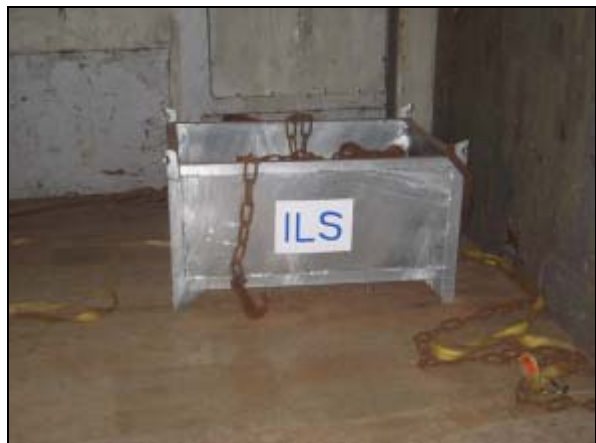
A metal bin used lashing gear

The bins had been ordered to replace “44 gallon” drums used to store unused lashing equipment. The master had originally ordered replacement drums, but the order was changed ashore as it was believed that the drums were unsafe and unreliable.

Prior to the introduction of the bins, no risk assessment was undertaken on the use of these containers in a ship where it was necessary for these containers to be moved, depending on the position of cargo within the hold. There were also no risk assessment carried out, either ashore or on board, on the difference in weight between a laden lashing bin and a laden drum, the latter being significantly lighter.

The bins were simply introduced into service and were secured in the same way the drums had been on previous occasions.

- Metal drums are not used any more to store lashing gear. They are replaced by metal bins.
- The metal bins containing the lashing gear will be stored in open top containers. The containers have 4 feet sides. The containers can be stored safely in any container bay in both the holds and on the weather deck. The securing of the container is done by help of twist locks.
- Fall arrest systems have been mounted in the access shafts to the holds both fore and aft.
- The safety instructions and workplace risk assessments for entering the holds have been revised.
- To enhance safety extraordinary safety meetings will be held and work instructions given.

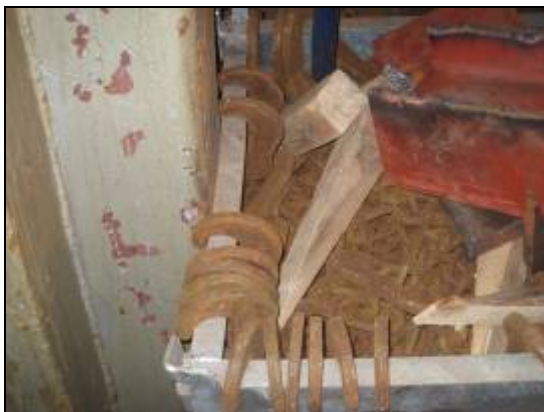
Bin filled with lashing gear

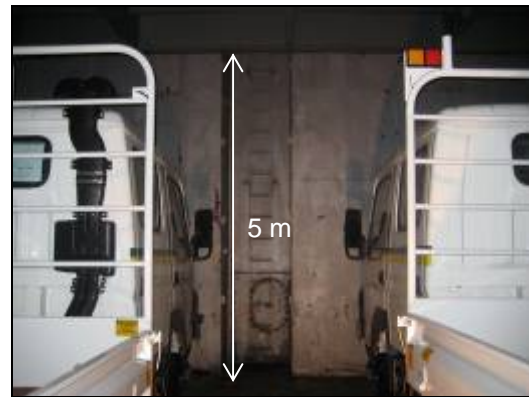
The ladder leading from the weather deck to the tank top is a metal ladder of a type commonly used in ships. It was not fitted with any kind of fall arrest appliances. There were no platforms from the hatch opening and down to the tank top in order to reduce the height of a fall. There were neither ladder hoops nor arrangements for fall prevention equipment in the form of rails or wires.

Ladder seen from the tank top

The access to the holds is through entrances in the fore and after part of the hold. Vertical steel ladders are leading from the hatch openings in the weather deck. There are not any platforms to reduce a fall from the ladder. Neither hoops nor arrangements for fall prevention equipment in the form of rails or wires were installed. From the tween deck to the tank top there was a distance of 5 metres. This enabled the possibility of a free fall of more than 5 metres while climbing up the ladder from the tween deck.

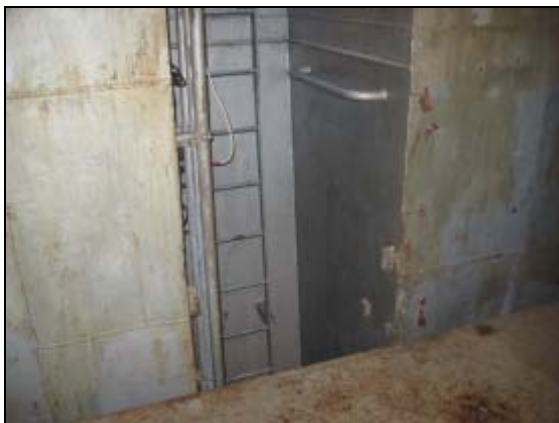
How to enter the tween deck from the ladder

To enter the tween deck it is necessary to straddle with one leg on the ladder and the other one on the tween deck. To facilitate this manoeuvre a rail to hold on to is welded to the side of the shaft.

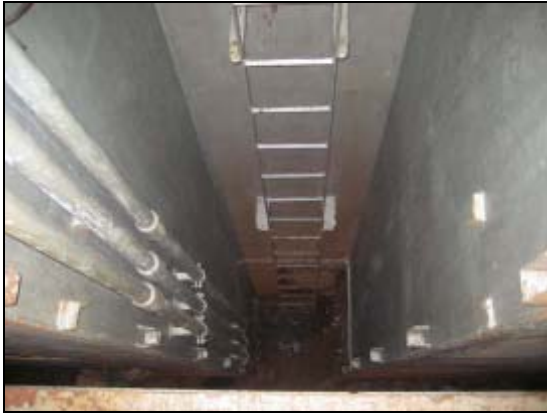
In the position the tween deck had at the time of the accident there was a distance from the tween deck to the tank top of 5 metres.

Ladder seen from the tween deck

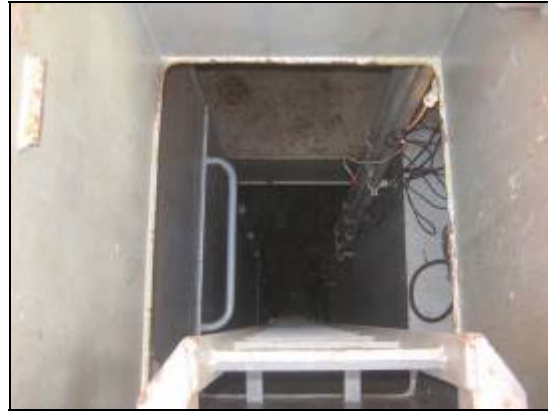
Ladder seen from the entrance to the hold

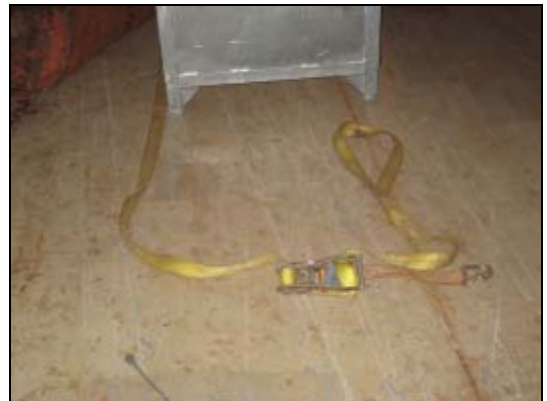
Web binder to secure the bins

It is likely that the continuous movement of the ship had slackened the web binders making the necessary force to break them considerable smaller.

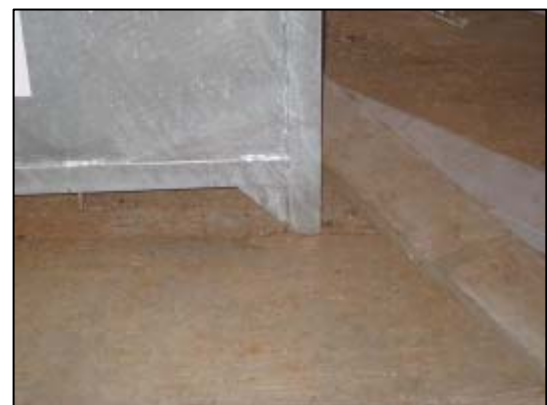
The metal “feet” of the bins

Consequently, the strops were secured to the container footings on the top of the port water ballast tank. On the bottom of the bins were metal bars. The bins and drums were standing directly on the tween deck and as the strops led upwards it did not apply any downward pressure on the bins. These circumstances had reduced the friction between the bin and tween deck contrary to bins and drums nested on wood.

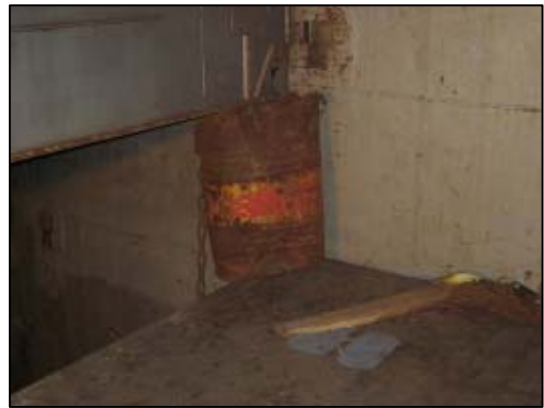
Drum caught between two sections of the tween deck

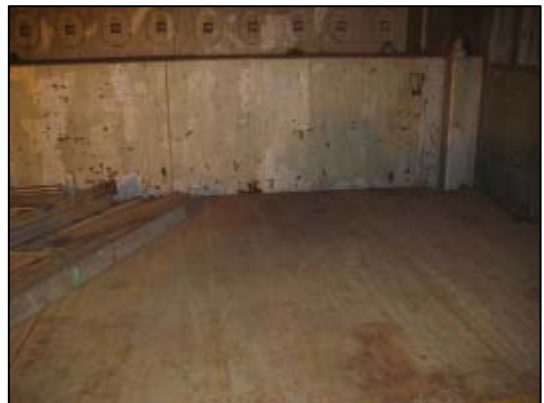
Skid marks from the moving bins
