MARINE ACCIDENT REPORT
DIVISION FOR INVESTIGATION OF MARITIME ACCIDENTS

TORM CAMILLA
Accident to seafarer 11 November 2009
Fall in fore peak tank

The casualty report has been issued on 03 February 2010

Case: 200914114

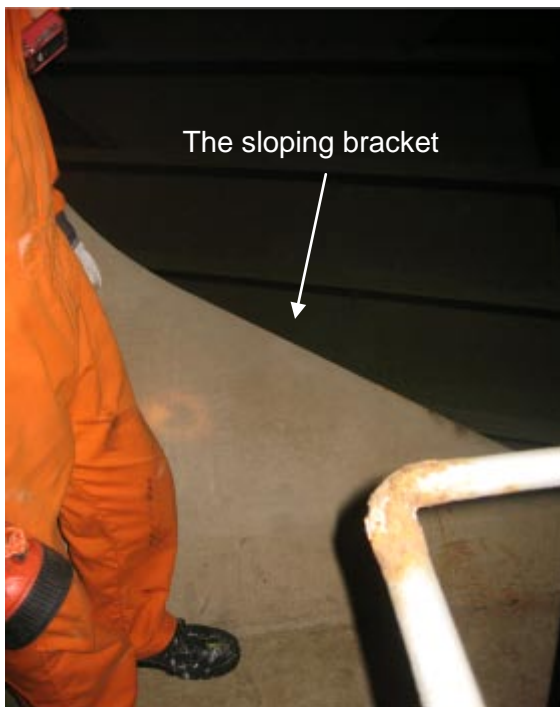
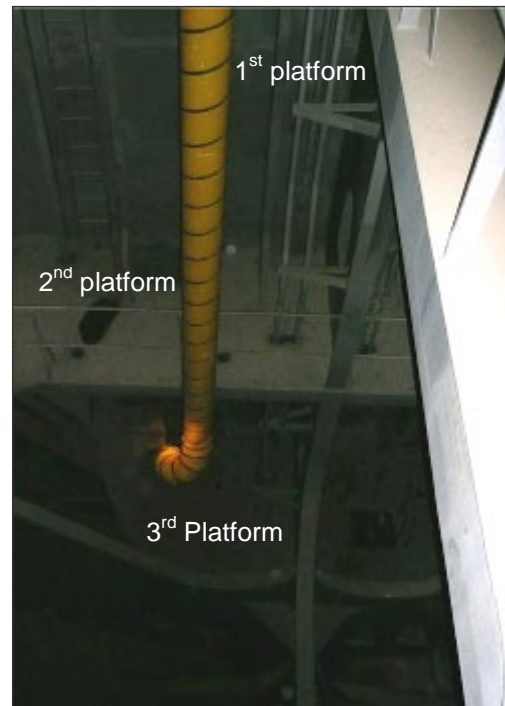
The fore peak tank consists of 3 platforms, 1st, 2nd and 3rd, connected by vertical steel ladders of an approximate length of 6 metres each. The platforms are staggered to prevent a fall of more than the height between the platforms. The platforms are fitted with railings and handles for safe traffic. The vertical steel ladders are not fitted with fall arrest fixing systems.

The lower platform is approximately 2 by 2 metres and has an entrance in the middle giving access to the bottom of the ship. On the platform there is a manhole to the well where the speed log is situated. On the port side of the platform there is a longitudinal bracket sloping from the transverse bulkhead on the aft part of the tank

and ahead. In the fore half of the platform the bracket flushes with the platform. There is an approximate height from the platform to the bottom of the tank of 1.8 metres.

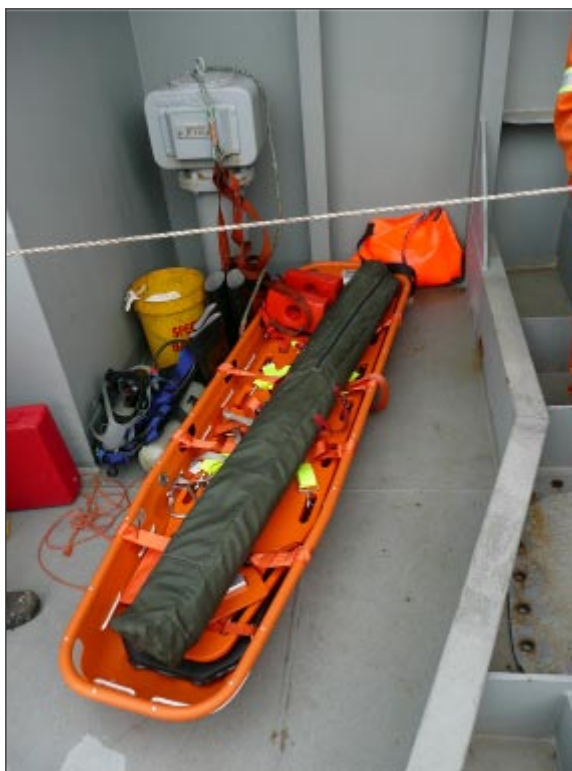
Safety equipment at the entrance to the tank

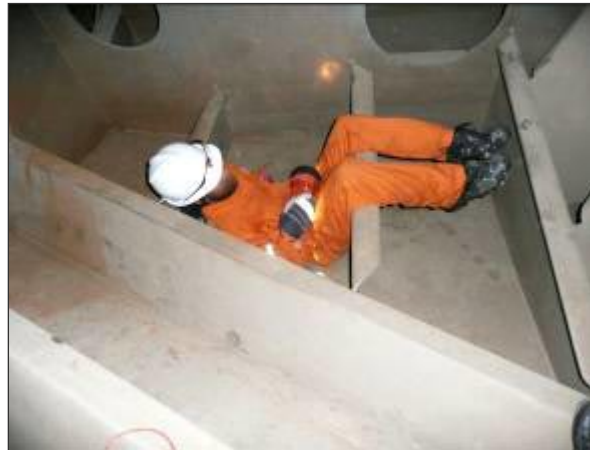
After reaching the platform the AB and the trainee pump man observed that the fitter turned to his right and moving his torch light as to orientate himself. The AB and the trainee pump man advised the fitter about his steps. Suddenly the fitter first took a small succeeded by a large step forward. He lost his balance and fell to his left over the sloping bracket and down to the bottom of the tank. The height of the fall was approximately 1.8 metres. In the fall his head hits a floor knocking his safety helmet off. He landed on his back.

How the fitter hit the bottom

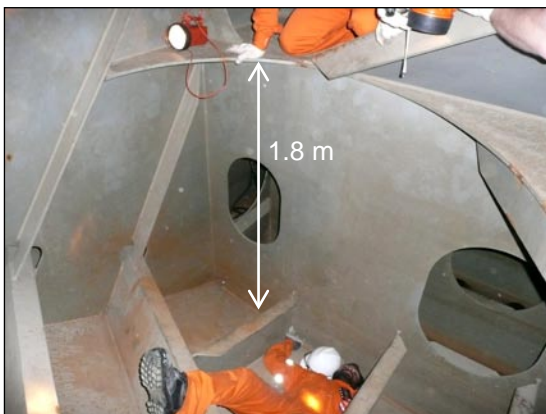
legs were resting against the floors with the body sagging in the space between the floors. Later the fitter rested lying on his back between two floors. Reaching the bottom of the tank the chief officer applied the emergency escape breathing device to the fitter. When the emergency self contained breathing apparatus was brought down it was applied to the fitter who quickly regained consciousness and he tried to remove the breathing device.

On the bottom of the tank there are floors with thin edges.

The Division of Investigation of Maritime Accident estimates that the thin edges of the floors increase the injuries to a person falling on them.

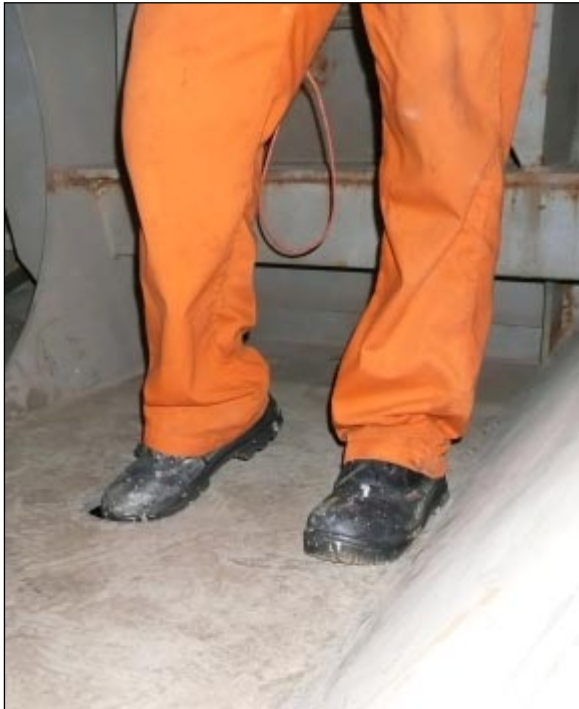
The fore peak tank was equipped with railing and handles to hold on to on the 1st and 2nd platform. However, on the 3rd platform in the tank there were not sufficient arrangements to prevent a fall to the bottom of the tank.

The Division of Investigation of Maritime Accident estimates that the lack of sufficient handles and railing on the 3rd platform brought along a potential danger of falling.

- The TORM A/S has issued a report about the accident. This report is distributed to all ships in the company's fleet and is to be discussed at safety committee meetings.
- A railing or a protection plate is to be fitted to the bracket in the forepeak tank. All sister ships in the fleet have received the same order.

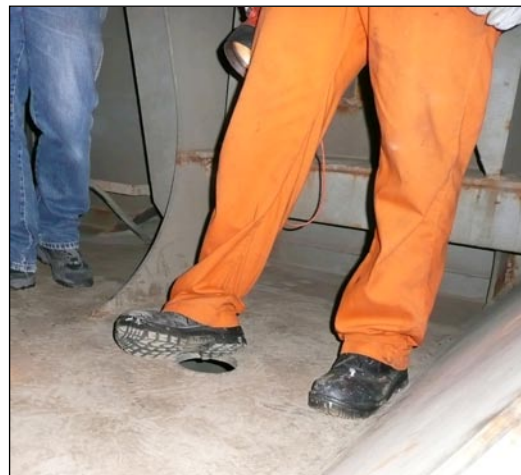
On all the platforms in the fore peak tank there are small circular openings to enable water to flow freely and to avoid sediment to settle on the platforms. These holes are large enough to enable the tip or heel of a shoe to get caught causing a person to stumble.

Holes in the platform where a shoe may be tripped

The Division of Investigation of Maritime Accident estimates that the circular holes in the platform bring along a potential danger of stumbling.

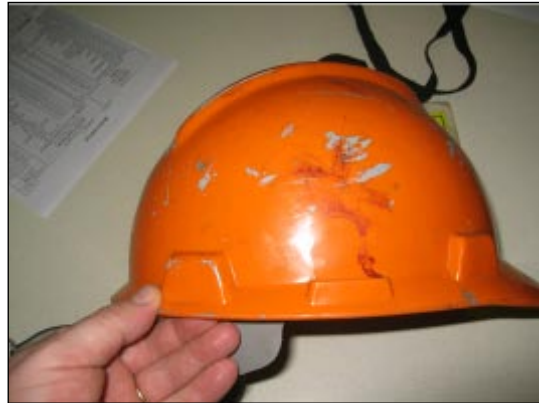
The ship was well equipped with personal safety equipment. At the accident the fitters' safety helmet was knocked of during the fall even though the chin strap was fastened.

The Division of Investigation of Maritime Accident estimates that the type of safety helmet guarding against falling object does not offer sufficient protection against an impact to the head caused by a fall.

Type of safety helmet used on board

1. The ship is recommended to evaluate all personal safety equipment to ensure that the equipment yields the necessary protection at any time. Special emphasis shall be given to hard hats/safety helmets.
2. The ship is recommended to evaluate and revise the work risk assessment focusing on the danger of falls.
