DANISH MARITIME AUTHORITY

**MARINE ACCIDENT REPORT
DIVISION FOR INVESTIGATION OF MARITIME ACCIDENTS**

**UNO
Accident to seafarer 22 March 2010
Injury while using grinder**

The casualty report has been issued on 27 July 2010

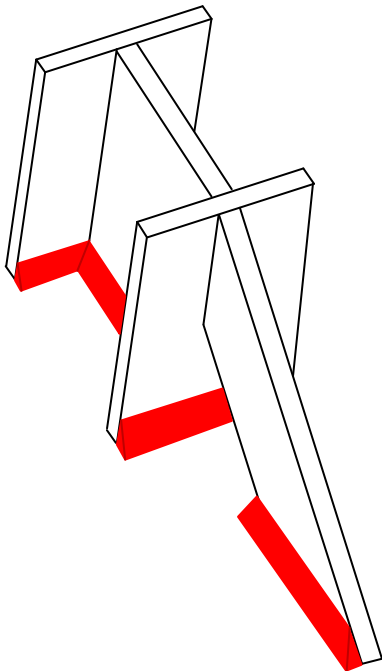
The cargo stoppers were pieces of a steel beam with an H-profile. The dimensions of the stoppers were approximately 25 x 25 x 25 centimetres. Each of the six platforms carrying the cable containers were secured on all four sides with three or four cargo stoppers.

A cargo stopper. Weldings marked with red

The way to secure the cargo from sliding on the tanktop was done by welding H-profiled cargo stoppers on the tanktop in a way making it difficult to remove them in an easy and safe manner.

The Division of Investigation of Maritime Accident finds that the way to secure the cargo from sliding was inexpedient.

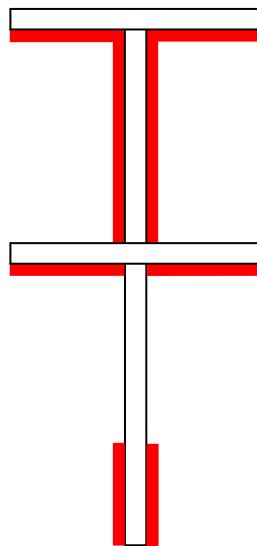
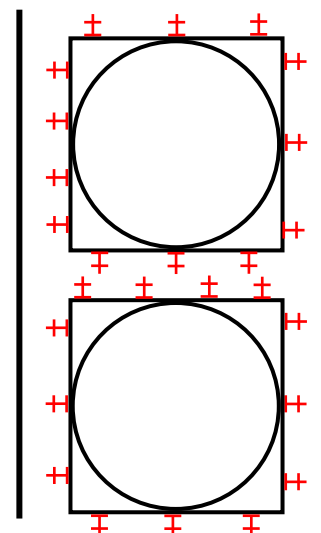
Cable containers and cargo stoppers seen from above

It turned out to be very difficult to remove the cargo stoppers as they were welded very close to the foundation on which the cable containers were placed. Furthermore the working space was very limited. The diameter of the containers almost matched the breadth of the hold. Between the cable containers and the sides of the hold there was only half a metre and between the cable containers there was the same limited space.

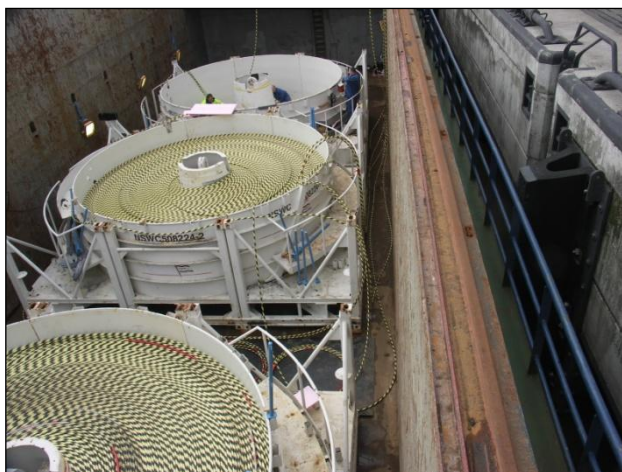
Due to the size and placing of the cargo only narrow passages were left for coming and going and working in the hold.

The hold

Due to the dimensions of the cargo occupying almost the breath of the hold, and the fact that the cable containers were placed close to each other only very limited working space were left for the work with removing the cargo stoppers.

The Division of Investigation of Maritime Accident finds that the limited working space made it difficult to remove the cargo stoppers.

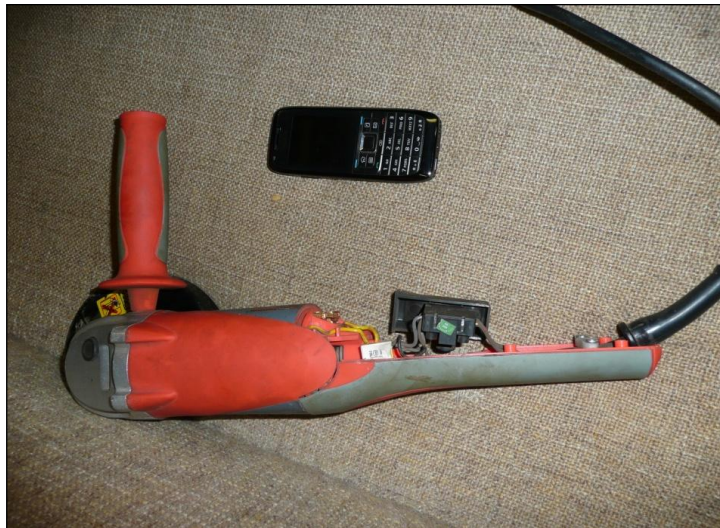
At about 1100 hours while the AB was using one of the ships own angle grinders to cut a welding inside the profile the grinder suddenly jumped upwards and hit his left hand cutting the ring- and long finger seriously. Nobody witnessed the accident.

The defektive angle grinder

The angle grinder used when the accident occurred was defect. The on/off bottom was locked in the on-position. The AB started and stopped the grinder by plugging and unplugging it. The grinder could therefore not stop if the user let go of the tool.

The Division of Investigation of Maritime Accident finds that the defective angle grinder endangered the user and increased the risk of damage because it could not stop if let go.

At the meeting there was a discussion on the importance of thorough inspection and testing of all tools before taking it in use and never to use tools with any kind of malfunction.
