## Report from the Division for Investigation of Maritime Accidents

# The grounding of **KARIN SCHEPERS** on 22 March 2009

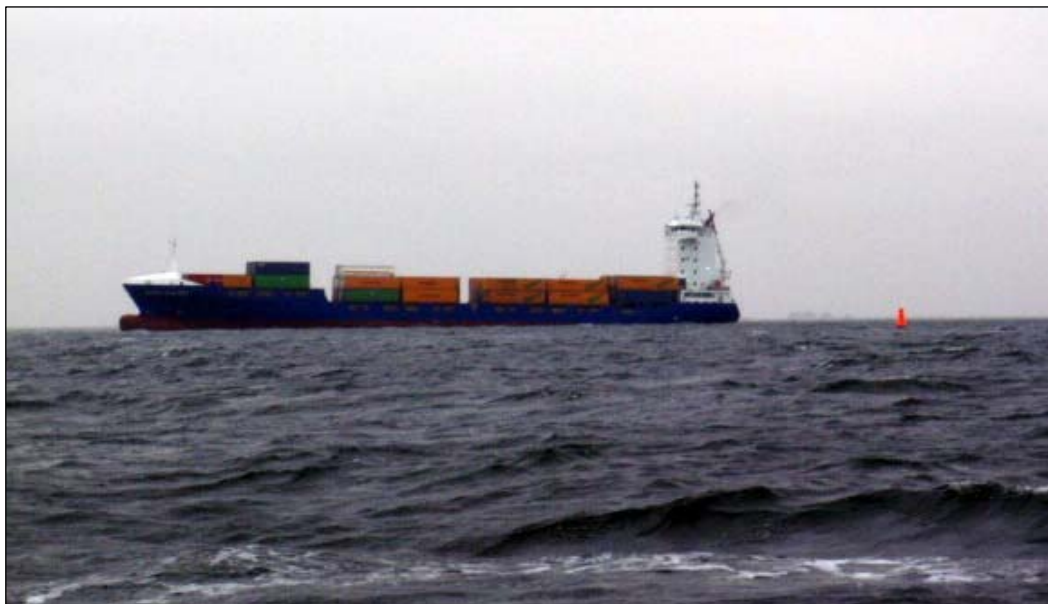
On 22 March at 0935 KARIN SCHEPERS grounded in position 55°39'44 N - 012°42'15 E, 0.9 nm north of Drogden dredged channel in the Sound. The speed when the ship grounded was 12 knots. The draft was 6.40 m fore and 6.60 m aft before the grounding. After the grounding the draft fore was reduced by 1.90 m and the draft aft was increased by 0.80 m.

Karin Schepers grounded in the Sound

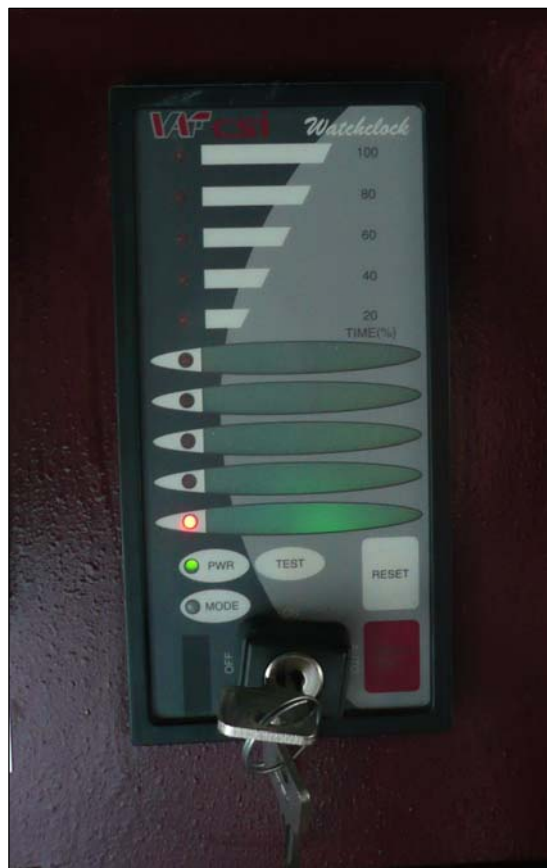
For the 10 days he had been on board the Bridge Navigational Watch Alarm System had never been switched on.

The BNWAS as found in position off.

- The chief officer was incapacitated due to intoxication.
- The chief officer fell asleep during his watch.
- There was no look out on the bridge.
- The Bridge Navigational Watch Alarm System was off.
- No crewmembers reacted on the various attempts to draw attention to the dangerous path the ship was taking.

- The shipping company is recommended to find ways to ensure that the Drug & Alcohol Policy (*Marlow Navigation Co. Ltd Drug and Alcohol policy*) is complied with.
- The shipping company is recommended to introduce procedures ensuring that watch keeping on the bridge always is optimal in the prevailing circumstances and conditions including the use of lookout and Bridge Navigational Watch Alarm System.
- The shipping company is recommended to promote safety management on board their ships by enhancing communication in order to make crewmembers think pro-actively and react in unusual situations.

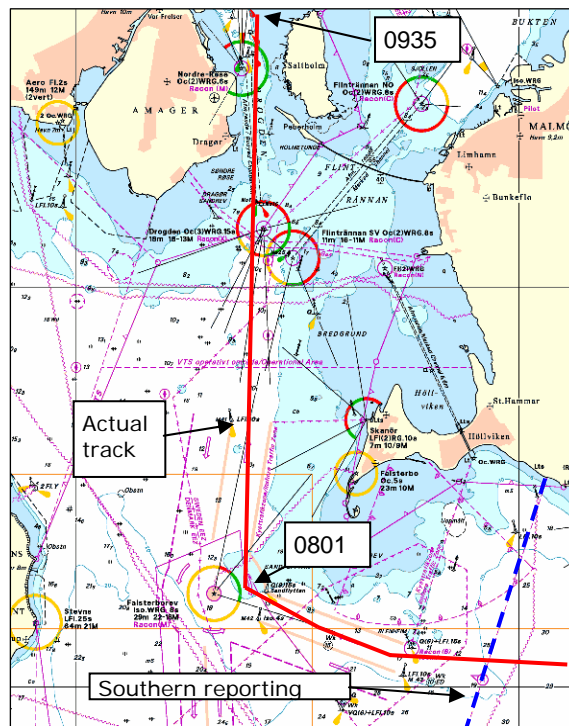
The last manoeuvre of the ship was at 0801 where the course was changed to 004° in the traffic separation scheme at Falsterbo. Several changes of course was planned to take place between 0801 and the time of the grounding at 0935.

Figure showing the track over the ground

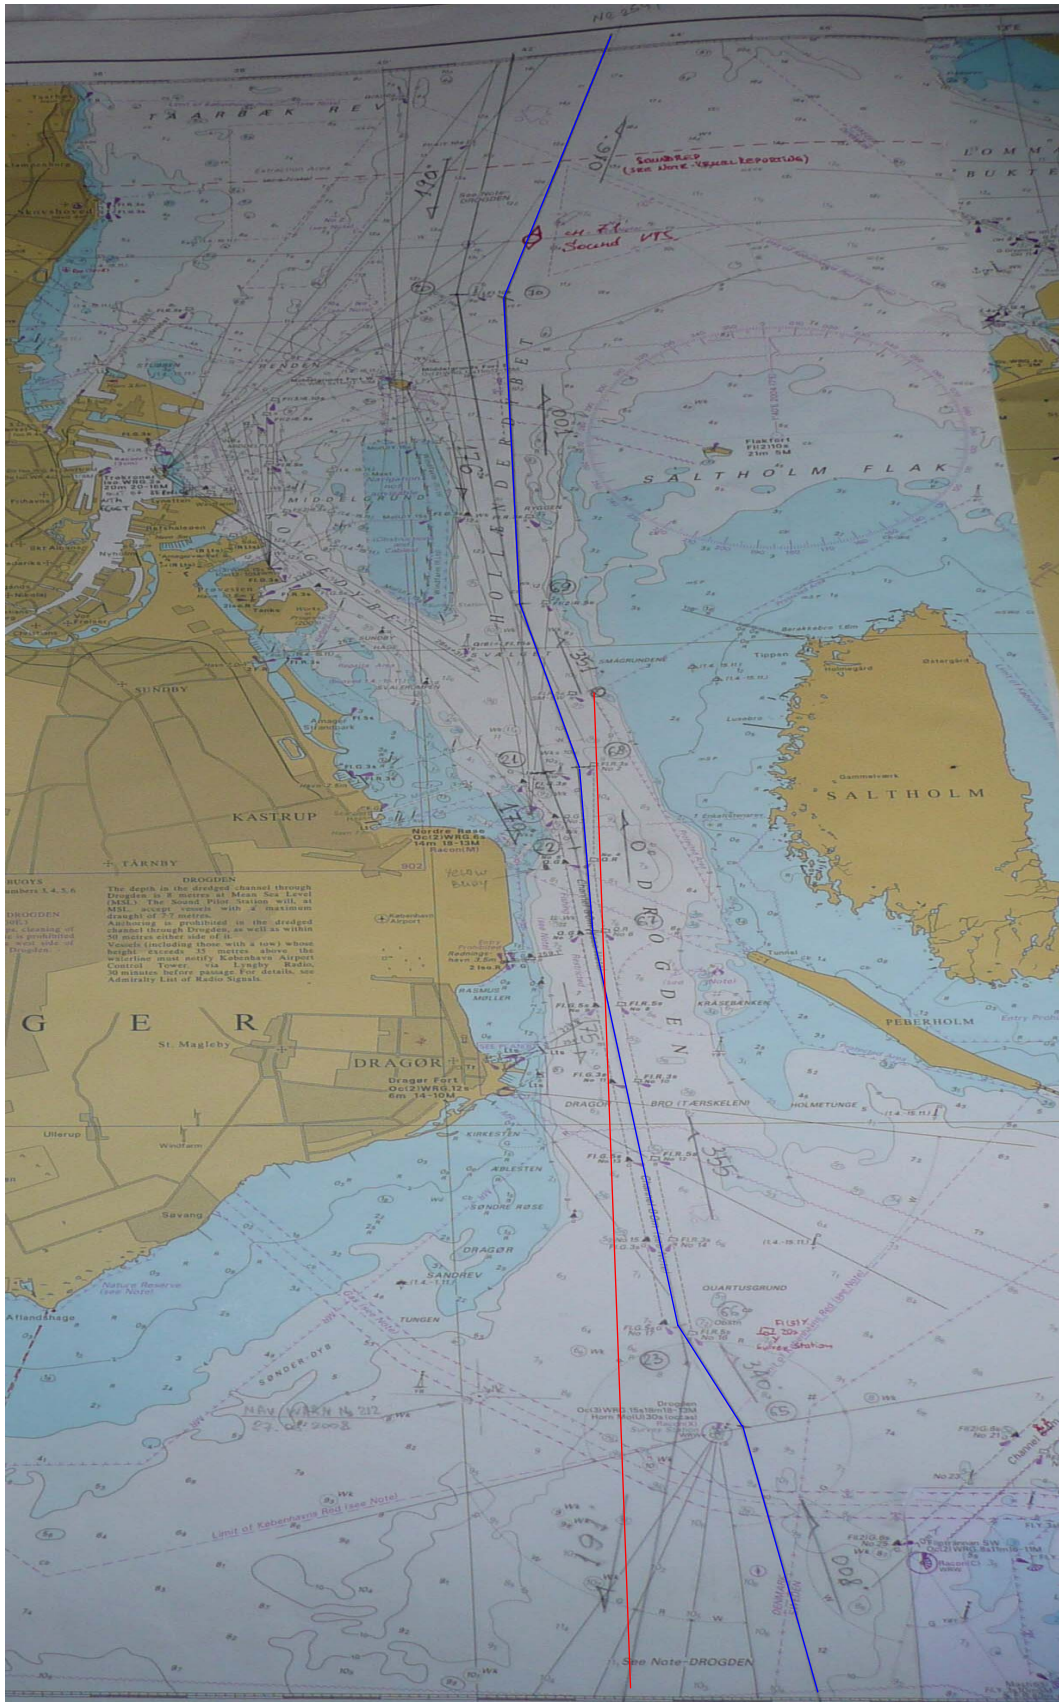
When entering the bridge he found the chief officer asleep in the chair in front of the radar and ECDIS. The sea chart on the chart table was covering an area from Bornholm to Falsterbo TSS and not the area where the ship grounded. The ECDIS was showing an area east of Falsterbo and not the Sound.

Photograph of KARIN SCHEPERS sea chart showing the planned track (blue line) and the track over ground (red line)
