**DANISH MARITIME AUTHORITY**

**MARINE ACCIDENT REPORT  
DIVISION FOR INVESTIGATION OF MARITIME ACCIDENTS** ———

**DANICA SUNBEAM  
Accident to seafarers on 18 November 2009**

**The casualty report has been issued on:** 20 April 2010.

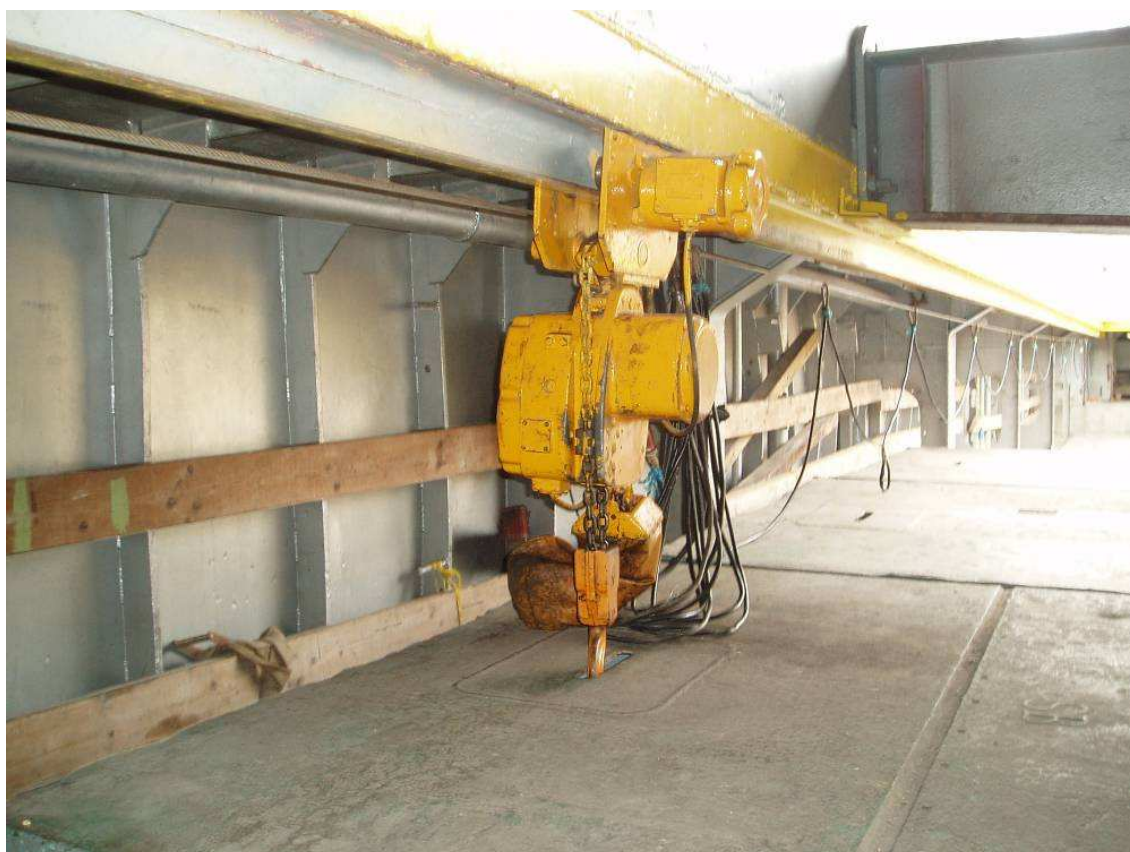
KITO crane (pulley) for removal/shifting pontoons

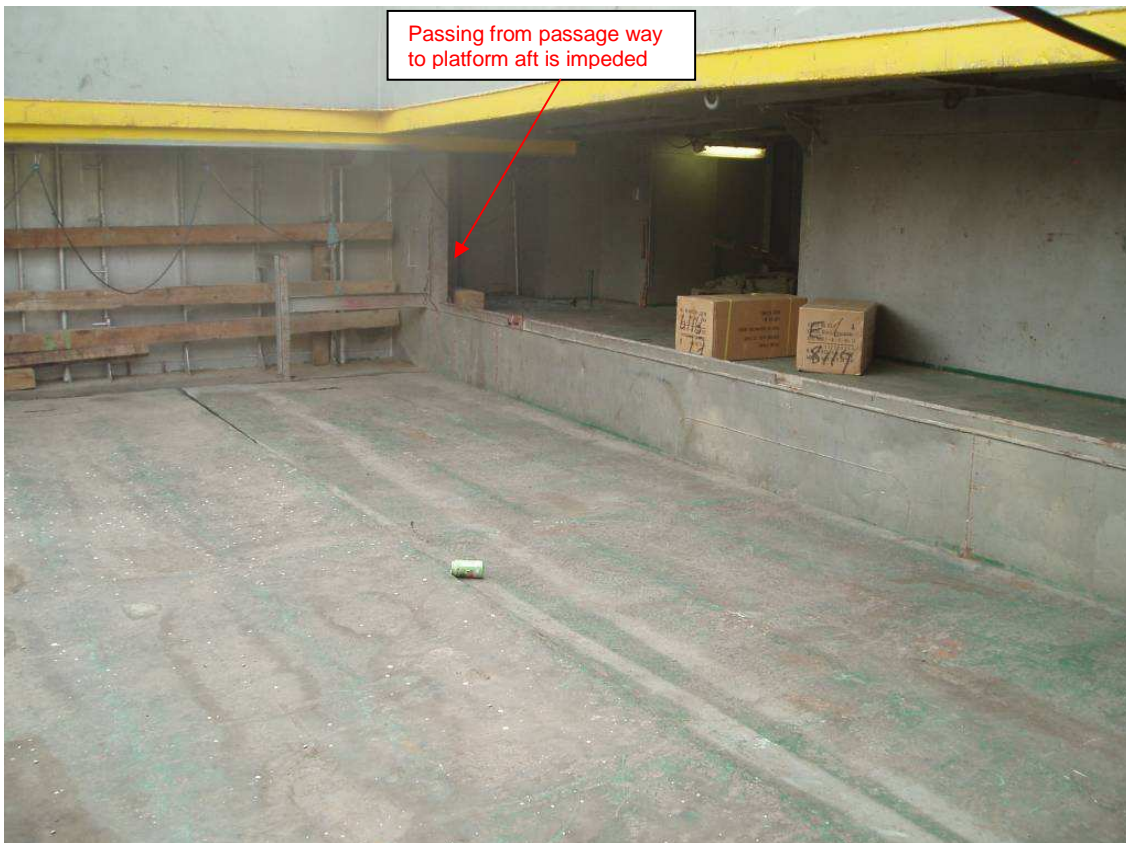
Tween-deck seen from port side, pontoon number 19 is closed

The Investigation Division considers the surroundings on the tween-deck unsafe when restacking pontoons, because one pontoon had been removed and thus created a wide open gap and the surroundings on the tween-deck unsafe because no barrier / roping off with ridge rope were used whilst restacking the pontoons.
