DANISH MARITIME AUTHORITY

**MARINE ACCIDENT REPORT
DIVISION FOR INVESTIGATION OF MARITIME ACCIDENTS**

**UNO
Accident to seafarer 22 March 2010
Injury while using grinder**

The casualty report has been issued on 27 July 2010

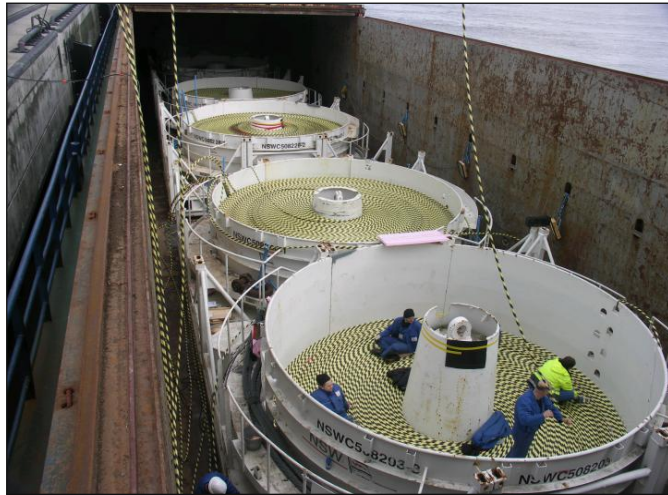
Winding of the cable in the cable container

The cargo stoppers were pieces of a steel beam with an H-profile. The dimensions of the stoppers were approximately 25 x 25 x 25 centimetres. Each of the six platforms carrying the cable containers were secured on all four sides with three or four cargo stoppers.

It turned out to be very difficult to remove the cargo stoppers as they were welded very close to the foundation on which the cable containers were placed. Furthermore the working space was very limited. The diameter of the containers almost matched the breadth of the hold. Between the cable containers and the sides of the hold there was only half a metre and between the cable containers there was the same limited space.
